Bank of Canada - Copper Building Envelope Repatination

Location Ottawa, Ontario
Designer / Architect Brook Van Dalen
Duration Apr 2005 - Sep 2005

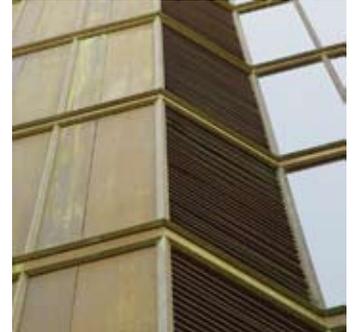
Panels, mullion caps, louvres and trim

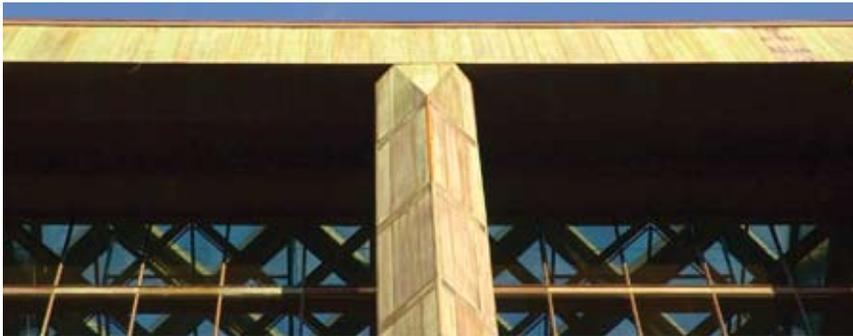
The patina to be matched for the entire building envelope

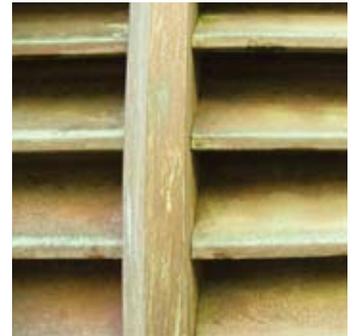
Close up of the louvres and their patina

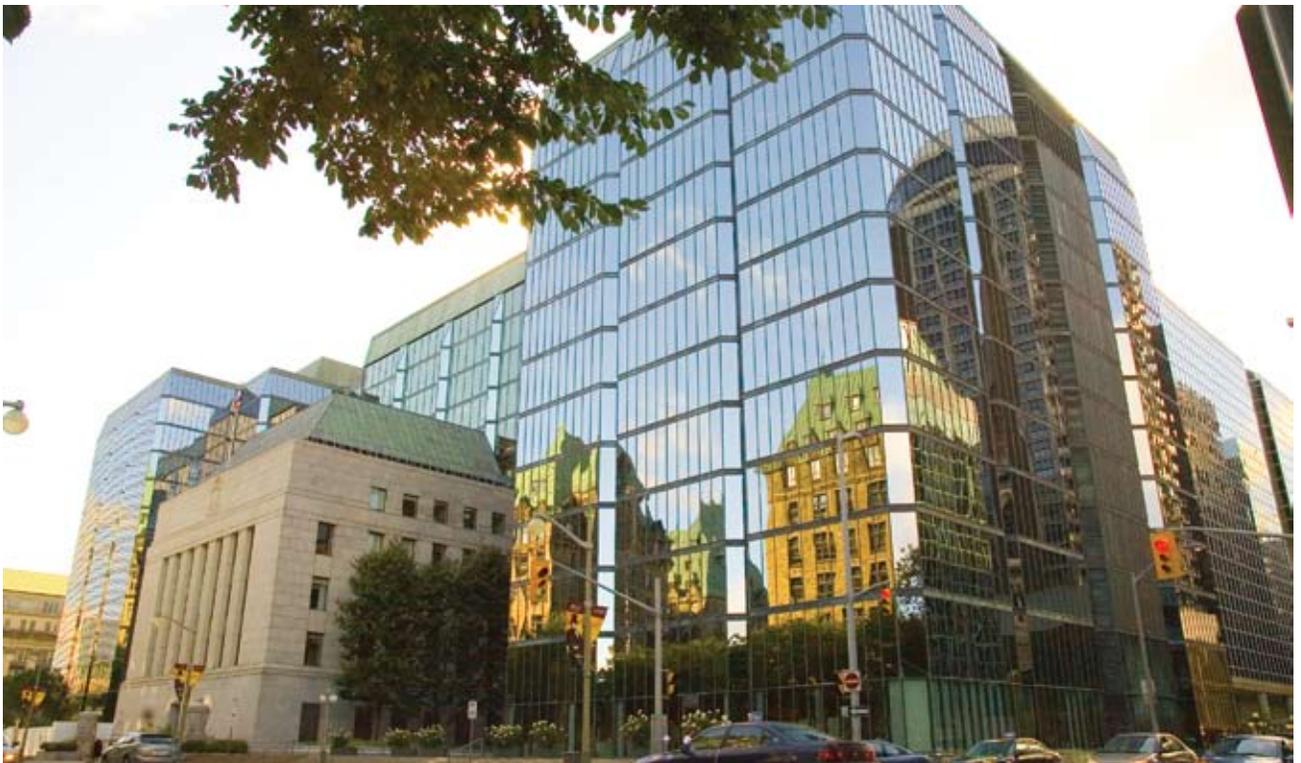
The Bank of Canada in Ottawa had it's glazing system and building envelope replaced in this remediation project

Highlights - More than 77,000 linear feet of copper mullion caps and trim were fabricated and patinaed to duplicate the original finish on the building envelope. Using SML's TrueGreen® Patination formula and technique, the design integrity of the original work was upheld while meeting the demands of the remediation. 0.50" rolled copper in 11' lengths was used to complete the mullion caps and trim with individual pieces custom made for spandrels and solid panels that required replacement.
